APETHORPE HALL'S JACOBEBAN CEILINGS

PHILIP GACHES

Work on the conservation and repair of the six Jacobean ceilings in the state apartments, and on one ceiling from 1740, began in spring 2006.

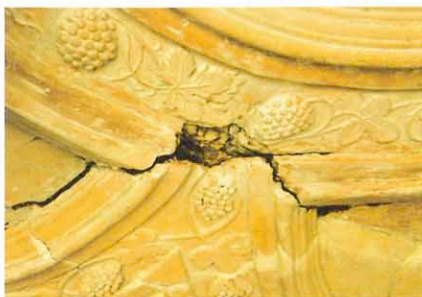
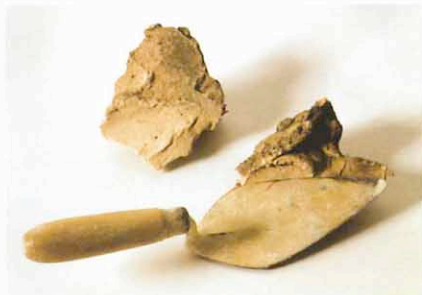
*Detail of damaged plasterwork from the Duke's Room: the circular motifs had been set out using centred lines scribed into the plasterwork above, but as the wobbly lines clearly show, no guides or rules were used when the ribs were formed.
(Below) Marks found on the plaster indicate the use of a blade similar to the small metal trowel used today.*

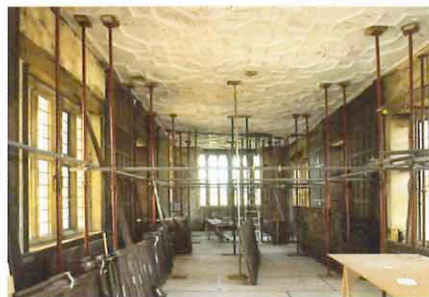
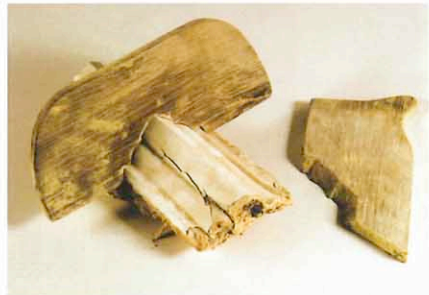
*The Long Gallery with its simple ornamentation of plain ribs
(Below) For the restoration of damaged sections of ribs, moulds were made from oak to match the original profile. The hand-held thumb mould which was used to achieve the final polished finish is shown on the right.*

Once the ribs were complete, the finish coat was applied to the flat ceiling between the ribs. No thin/fine coat was found in the original work, which leads us to think that the surface of the ribs was worked to a smooth finish by polishing with a thumb mould. The mould used for our repairs was made of 8mm-thick oak (see illustration on page 213). The profile was angled so that it could be used to bring the latence (the small particles) to the surface and polish it.

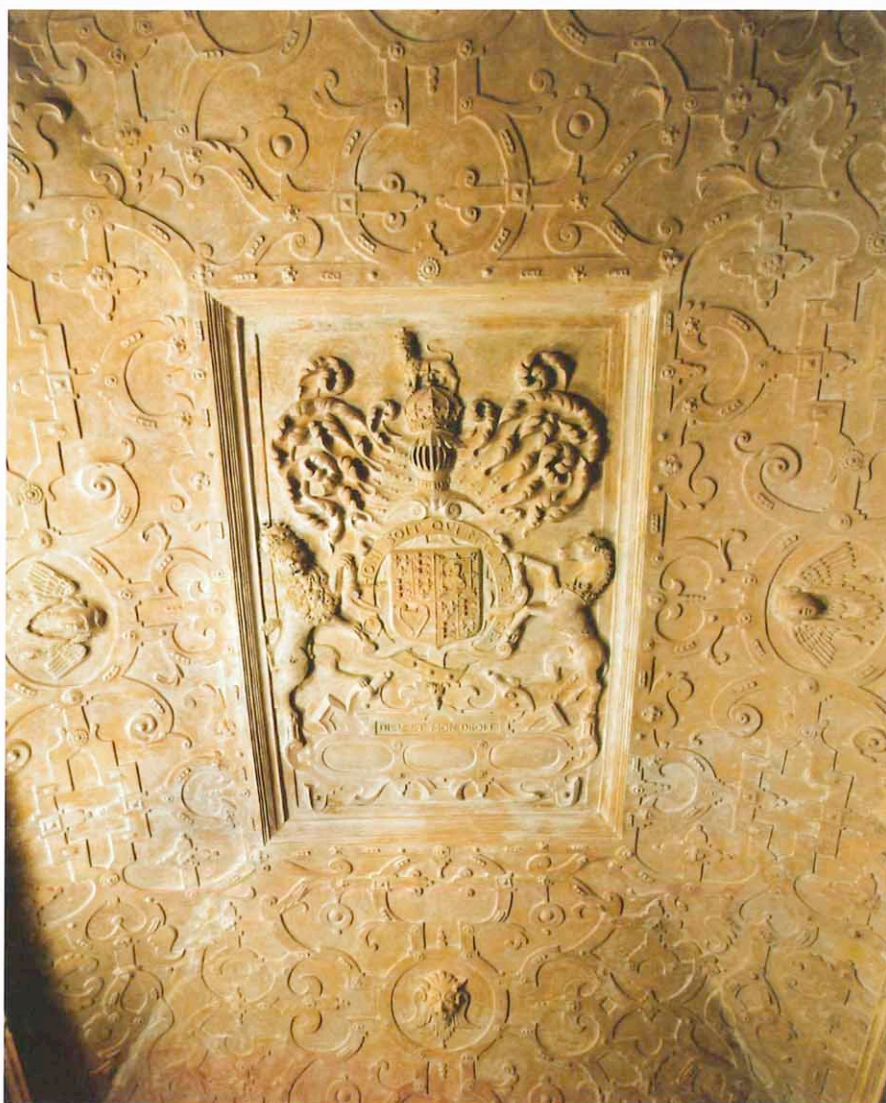
The King's Room ceiling and (right) a detail of its heraldic central panel before and after paint removal

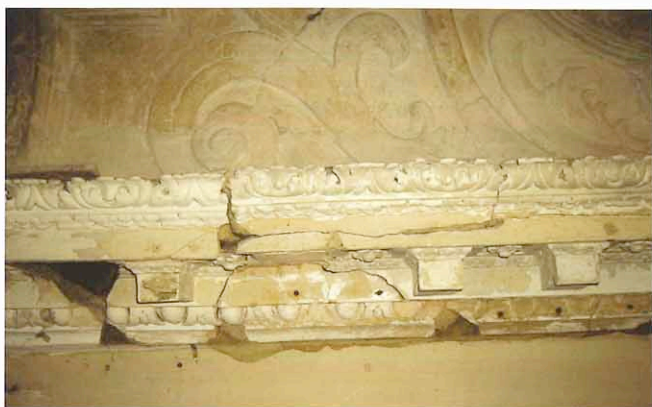
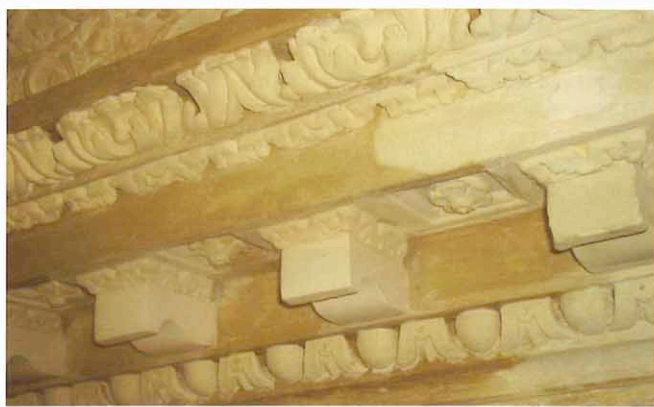
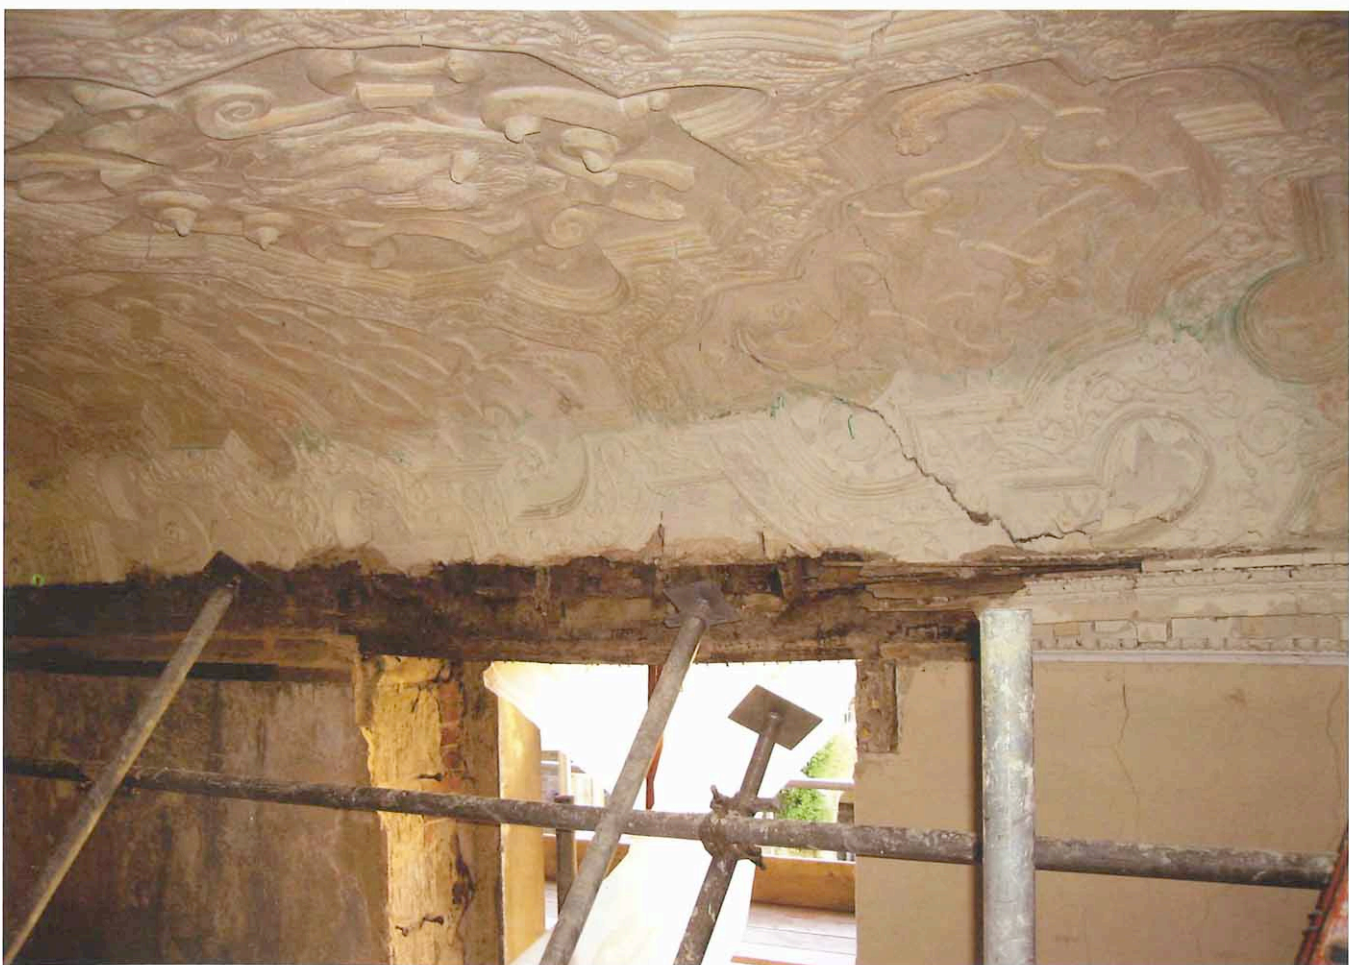
Damage to the cornice in the Dining Room necessitated structural stabilisation and the reinstatement of missing components.

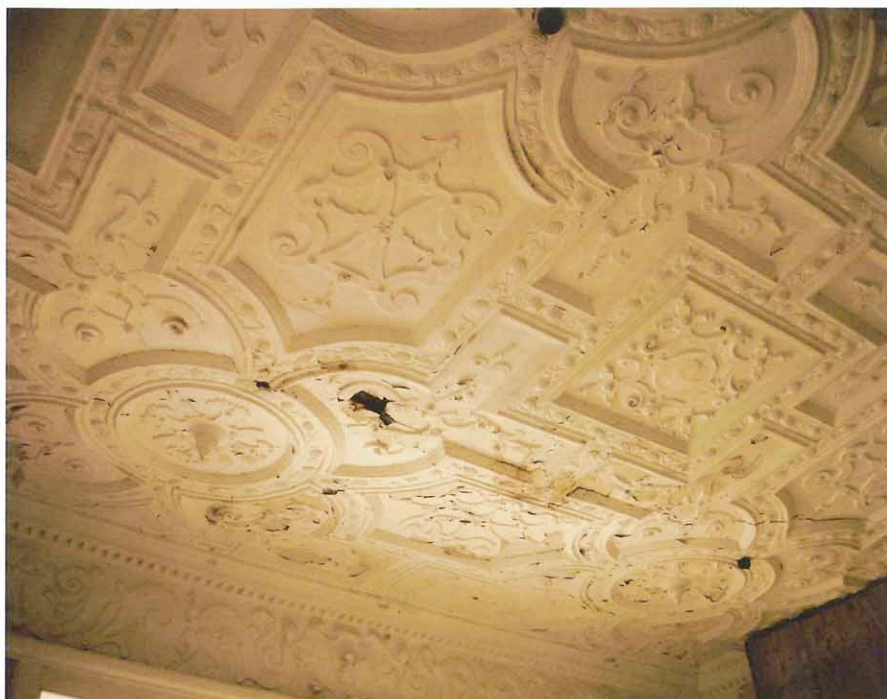
The Duke's Room ceiling and (below) the replacement for the missing central pendant

The central pendant was missing here and a new one was made using the repair mortar. It was modelled in a single coat and the basic shape was hand-formed. This was then left for two days to stiffen, at which point the decoration was modelled onto it. The whole process took no more than one hour in actual working time and no cracking occurred in the mortar, which was up to 125mm thick.
