Apethorpe arising

It is one of the largest single repair and refurbishment projects ever undertaken by English Heritage, calling on the skills of a wide variety of specialists and craftspeople. On page six of this edition of 'Cornerstone' we visit the site now, while here and on the following pages the experts tell of their work – after the momentous compulsory purchase in 2004 the vital second stage to save and prepare this Jacobean gem for an eventual new owner. First, **Mark Balkham, Stephen Oliver and Stafford Holmes** of architects **Rodney Melville & Partners**

Rodney Melville & Partners were appointed Architect for the Phase 1 repair programme in May 2005. Although not necessarily immediately apparent from the exterior, much damage had taken place internally due to leaking roofs and parapet gutters together with blocked sumps and rainwater downpipes. This had resulted in failed ceiling structures, floor structures and damaged plasterwork. To avoid the potential complete collapse of some of the most important decorative plaster ceilings, crash decks had been installed during previous Urgent Works below ceilings in most of the first floor East and South Range principal rooms

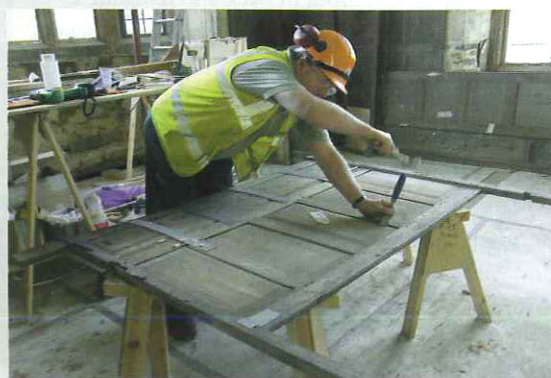
Left, Martin Stapleton of E Bowman & Sons repairs the Long Gallery panelling. Above, the East Range roof before repair

All the panels and pilasters have been carefully taken down to enable recording, inspection and repair. This had to be carefully co-ordinated with the main sequence of working to repair the floor and ceiling above, and manhandling of the panels was a particular challenge until the crash deck and its scaffold base had been removed. Conservative repair techniques were used, following a masterclass held in the Long Gallery with Ray Stevens, the National Trust's joiner at Hardwick Hall and a former William Morris Craft Fellow. The aim of these techniques was to reduce the amount of historic timber lost when carrying out conventional piecing-in repairs. Stainless steel patch plates, thin enough to be bent to suit the irregular shape of the rear face of the panelling members, were used to reinforce failed mortice and tenon joints. They have also been used, with oak packers, to gently push the crushed upper panels back into shape, so that the split ends of timbers could be woven back together without the need for glue.

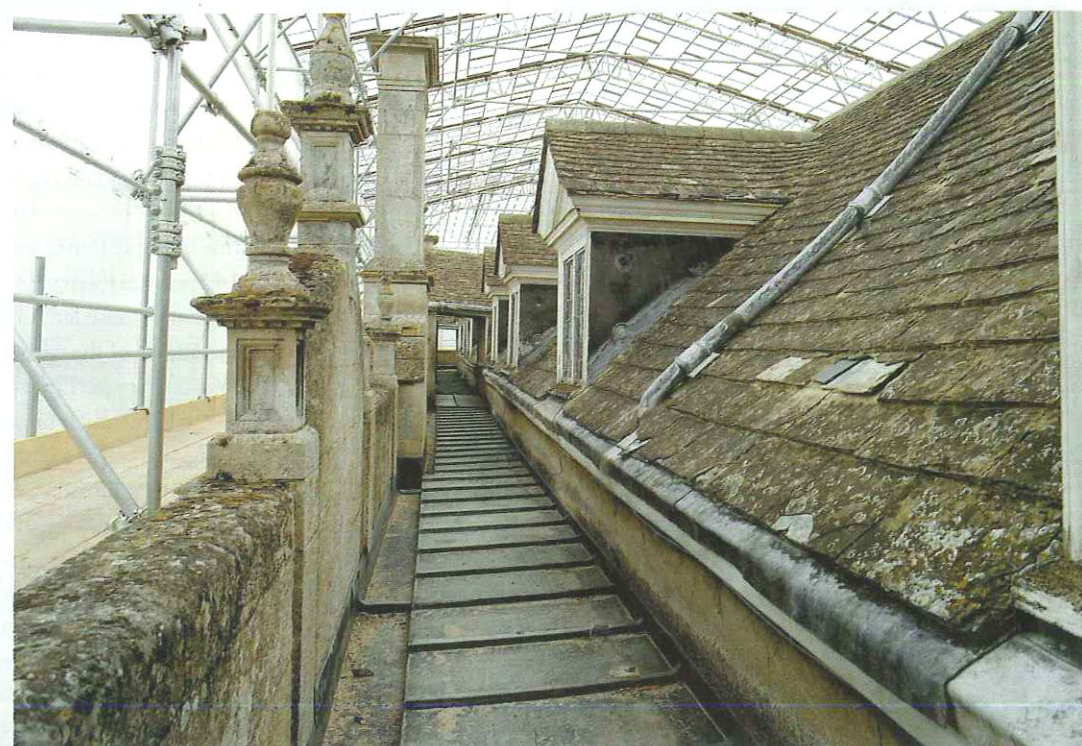
It was recognised that a major scope of repairs was required to the Collyweston slated roof slopes over the East Range. With advice and guidance provided by both Terry Hughes (Slate and Stone Consultants) and David Ellis, Collyweston slater, proposals were developed for re-slatting the East Range roofs. This was considered one of the biggest challenges as Collyweston slate is no longer quarried and new slate is currently unavailable. During the enabling works, trial areas of slate from the East Range were removed to establish the potential salvageable quantity of slates that might be achieved. The proposed

removal of the 1950s Collyweston-slated Hunting Way semi-detached houses on the site provided the possibility of reusing Collyweston slates from the semis to make up any shortfall. Following trials, it was established that approximately 50 per cent of the Collyweston slates on the East Range were likely to be salvaged for reuse although expectations have been exceeded with approximately 70 per cent now being reused. Slates are being refixed and spot bedded and pointed using hydraulic lime mortars with provision for bat access. To provide added protection, slates have been fixed over a vapour permeable sarking felt. Sample areas of slating were carried out before proceeding to discuss and establish criteria in relation to quality of workmanship. The Collyweston slating is being carried out to a very high standard by E Bowman & Sons' own Collyweston slaters.

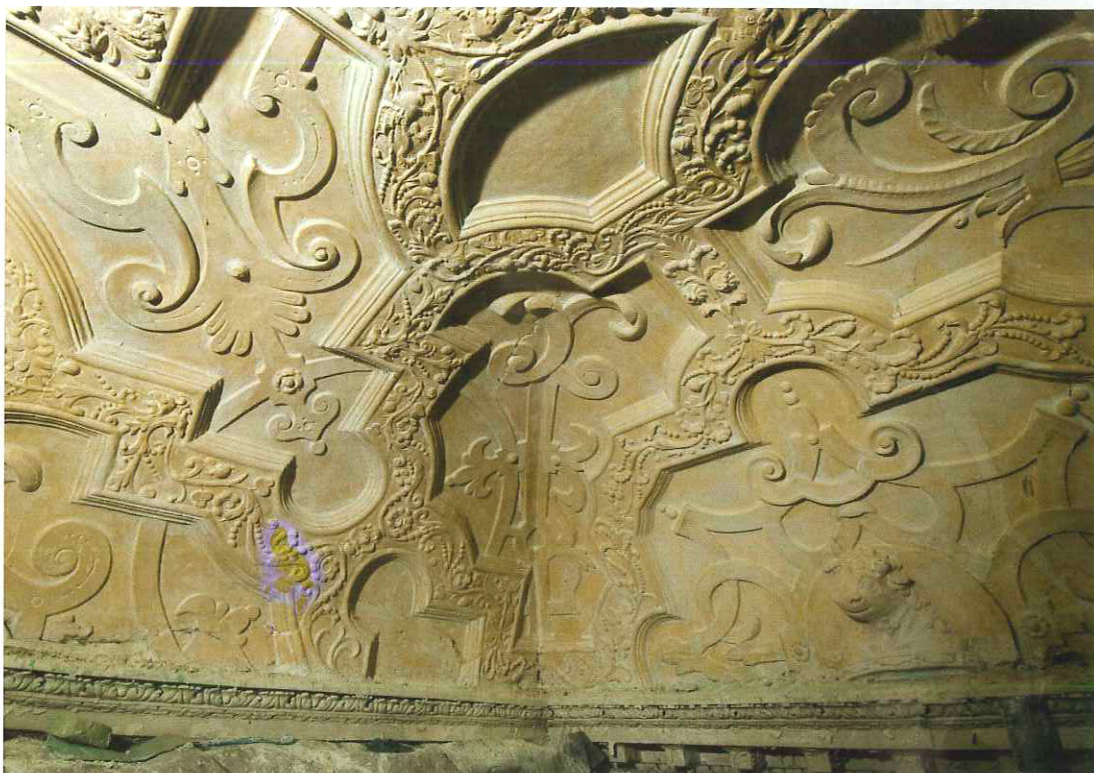
Above, some of the lavish ceilings, this section in the Great Chamber, 1620s. Left, Collyweston slate being laid – work by Bowman's

Defects to the ceilings at the time of acquisition by English Heritage were directly related to the normal decay mechanisms associated with water ingress from failing roof finishes and gutters. These defects included timber decay to wall plates, joist ends, beams, ceiling laths and cornice brackets. The majority of serious defects were located close to or at ceiling-to-wall junctions. The most serious failures were to the north cornice of the Great Chamber and the Long Gallery ceiling adjacent to the west cornice and at the north end of the Long Gallery, below a failed beam. These areas had suffered partial collapse and some loss of original material.

The partial collapse and detachment of the Great Chamber north cornice was a major conservation and repair challenge. The option of reforming new support brackets and running a new cornice to replace the fallen section was considered. Following trials, however, it was found possible to salvage and conserve the majority of the original cornice despite the absence of the timber support brackets which had been lost due to decay. Reconstructing the brackets in full was not an option as conservation of the run and embellished cornice precluded lathing up and running new. Refixing and making good the original cornice fragments was a delicate task involving the careful and accurate insertion of stainless steel rods through pre-drilled holes to support the replaced cornice sections.

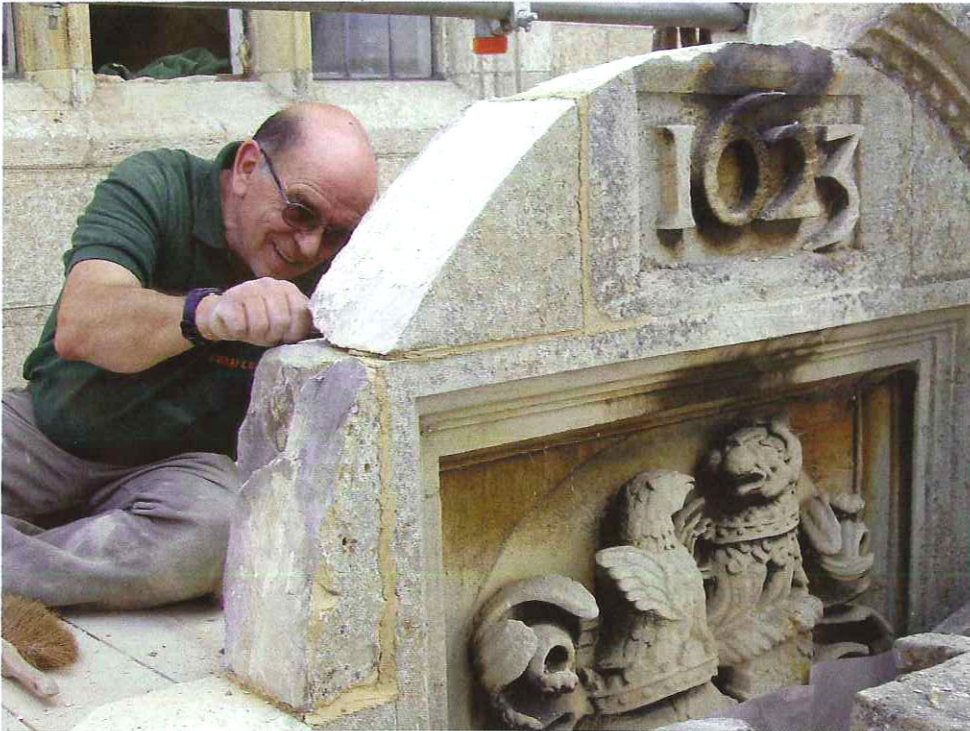
Generally, the stonework is in good condition, although extensive areas of pointing had failed at high level, in particular to the chimneys, copings and other weathering details. In addition, some inappropriate cementitious pointing had been carried out to extensive areas of the coursed dressed rubble stonework to the South Range. Large areas of pointing had fractured and had become detached from the stonework. Damage had also occurred through corroded iron fixings to some of the chimneys and gables.

Far left, one of Bowman's stonemasons repoints the East Range gable. Left, one of more than 800 masons' marks found at Apethorpe, this one on a fireplace

As King's Cliffe stone is no longer quarried, extensive research was carried out to find suitable alternatives. English Heritage was fortunate in having a stock of Weldon stone (also now no longer quarried) at nearby Kirby Hall, some of which has been used for the repairs. Clipsham stone has been used for repairs to weathering details. A range of lime mortars were prepared for matching and selection. Different mortar strengths with varying aggregate sizes have been used to suit joint sizes and exposure. Repairs to damaged stonework have included isolated replacement, piecing-in and mortar repairs depending on the detail, location and severity of the decay. Masonry repairs are carefully being carried out by Bowman's own masons.

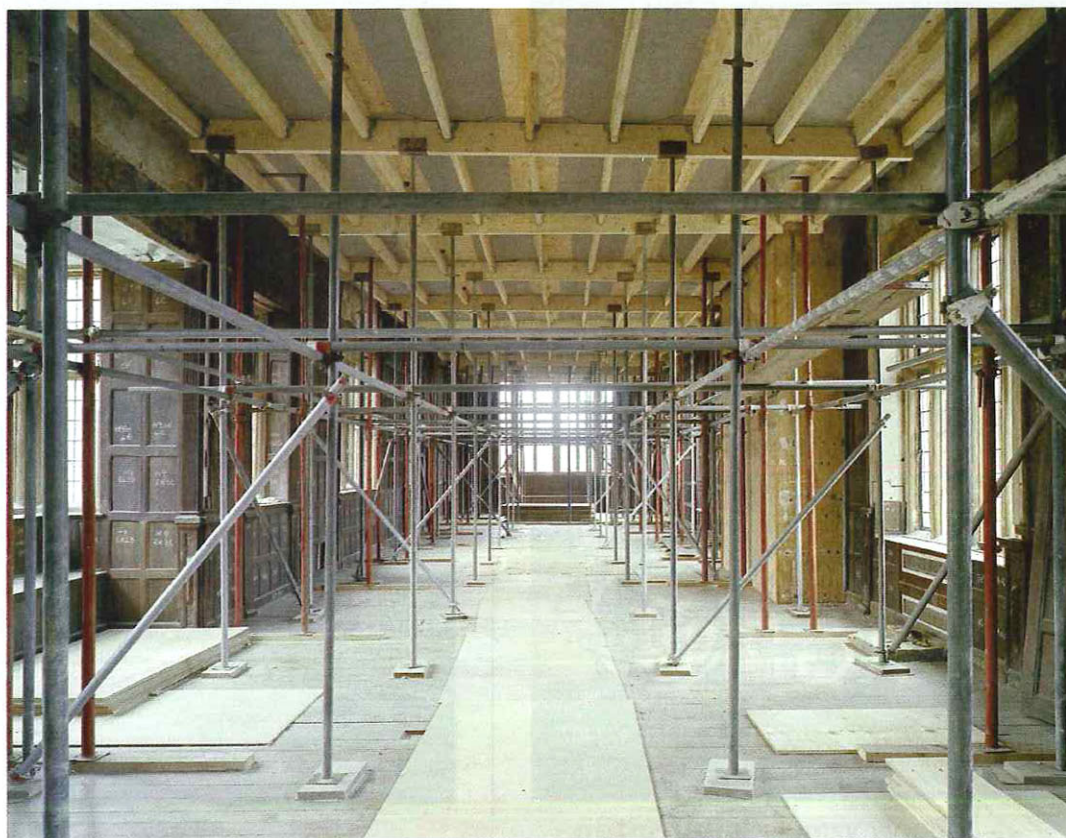
The Long Gallery – some 33m, in fact – under repair last year. Structural problems had to be rectified before plasterwork could be cleaned and conserved

The Long Gallery in the East Range, is 33 metres in length and has a very fine Jacobean ceiling, which is fixed directly to the underside of the second floor dormer roof structure. Failures in the roof covering and deflection of the main supporting beams led to several leaks through this fine ceiling. There are 18 primary horizontal timber beams supporting the second floor over the Long Gallery and other principal rooms. These oak beams are approximately 325mm square and span 7m and support the second floor accommodation and the heavy Collyweston roof covering.

The main point of weakness of this roof therefore is the knee joint of the east slope of the principal rafters. Most of these joints have failed and the roof frames slumped sideways toward the east. The horizontal movement of this joint is up to 180mm. As a consequence of this movement, many of the roof frame joints have opened and the ridge has dropped. The eaves line also varies greatly. These fractured knee joints in the principal rafters on the east slope have now been strengthened by the insertion of steel fitch plates.

A second weakness of the roof structure is the deflection of the main floor beams at second floor level under the weight of the floor and roof loading. Two of the 18 beams had failed and the remainder have very significant deflections in them. As a result of the deflection in the second floor, the roof frames have dropped. The strengthening of the main floor beams at second floor level has been achieved by cutting fitch slots for the full length of each of the main beams and introducing steel stiffening plates. The fitch slots were cut

by means of a chain morticer. The steel plates were fabricated to the deflected profile of the beam. Rotafix resin was used as a void filler and adhesive and bolts at regular centres connected the timber to the steel flitch plates.

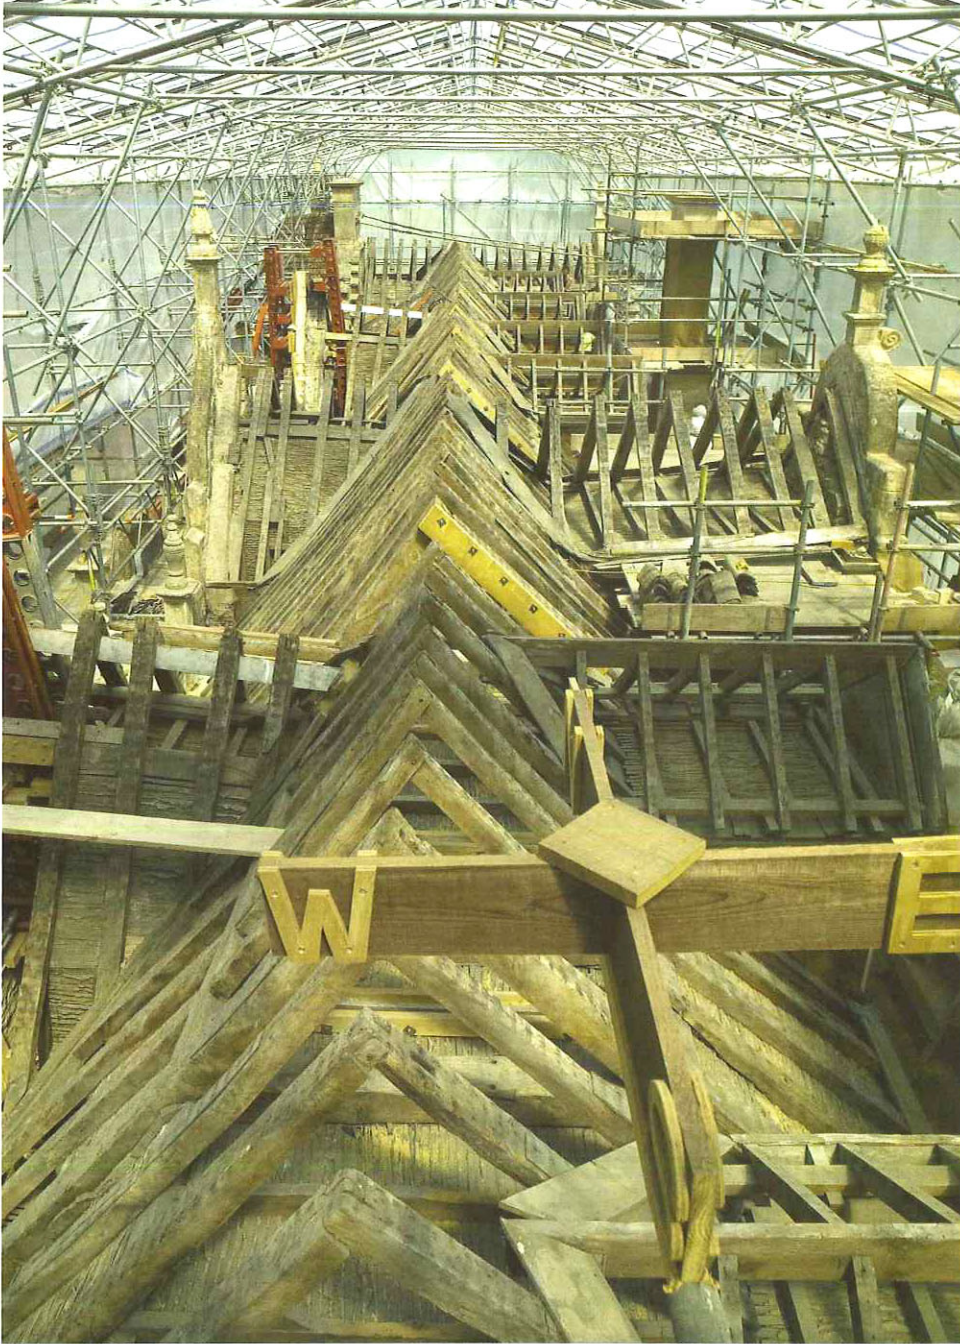
All is revealed: East Roof repairs in 2005. Embedded timber wall plates on the East Range had deteriorated

A further consequence of the failure of the East Range gutters and roof coverings was the deterioration of embedded timber wall plates. This led to the leaning of two of the three gables on the west side. The lean was approximately 300mm in the height of 4.5m, and collapse of the gables was only prevented by the buttressing action of the adjacent roof slopes. In order to strip and re-fix the roof slates, it was necessary to temporarily restrain the gables. A system was devised using RMD Kwikform. This provided the opportunity to restore the gables to the vertical. Using Superslim Soldier support frames and two adjustable push-pull props, the gables were eased back to the vertical. This avoided the loss of historical detail which would have resulted from taking down and re-building the gables.

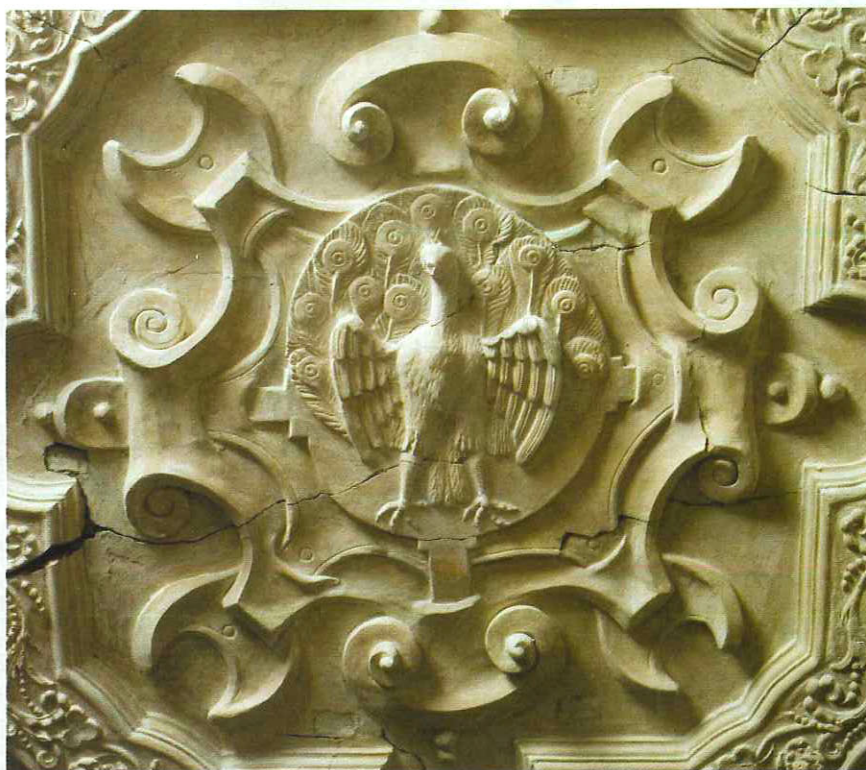
A peacock motif in the Great Chamber ceiling, showing cracking prior to repair and conservation

The overall pattern and uniformity of finish to the ceilings was completed by hand modelling and repairs, with great attention to detail using plaster mixes and techniques which closely matched the varying periods and styles of the original.

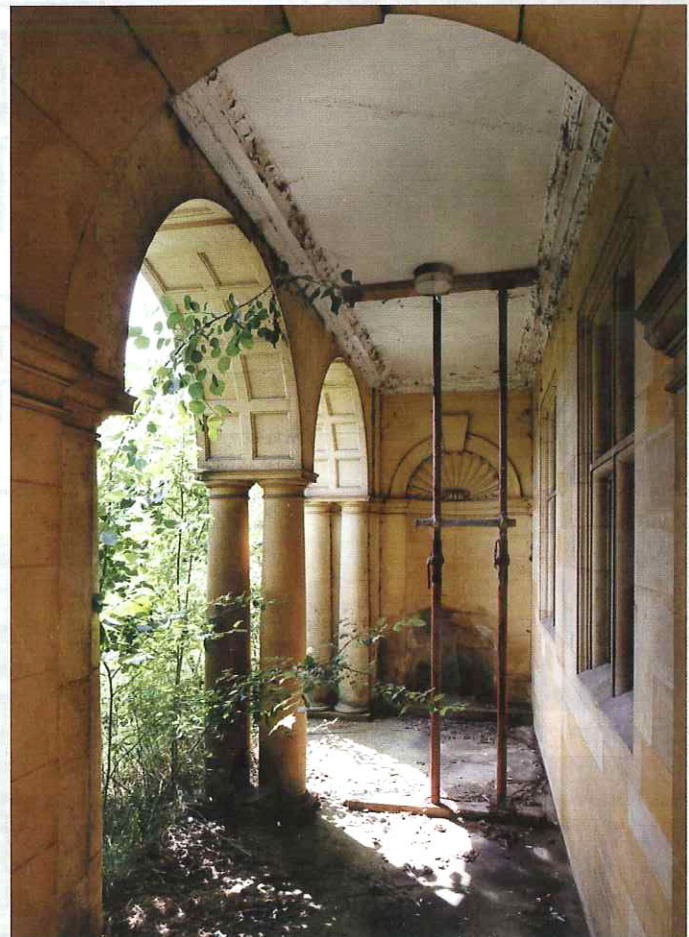
Right, protected during conservation, a 1620s statue of James I. It was originally located over the main doorway into the State Apartment. Below, the very dilapidated arcade in the East Range in 2000
