JACOBEAN SPLENDOUR

The restoration of 200m² of decorative ceilings dating from the Jacobean period challenged the flexibility of modern products, finds *Kaye Alexander*

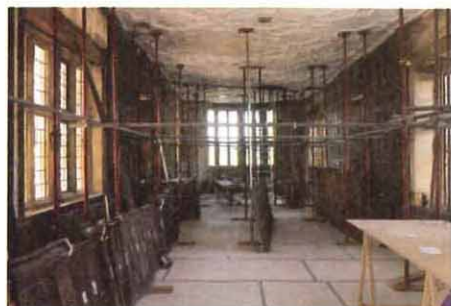
This image Before and after showing the painting of one of the ceiling's ornate details
Far left top Structural support for the Long Gallery ceiling
Far left bottom Large cracks in a plaster detail before restoration

First the ceilings were thoroughly cleaned and numerous layers of paint removed. Then the cracks were blown with compressed air to remove any debris. 'In the 1740s, the roof space was converted into rooms,' says Gaches. 'During this work huge sections of triangulation were cut from the principle trusses. This

caused the whole structure to move and large cracks developed in the ceiling plaster below, in line with the trusses. The plaster had become detached and there was also some water coming in.'
