APETHORPE HALL'S JACOBEBAN CEILINGS

PHILIP GACHES

Work on the conservation and repair of the six Jacobean ceilings in the state apartments, and on one ceiling from 1740, began in spring 2006.

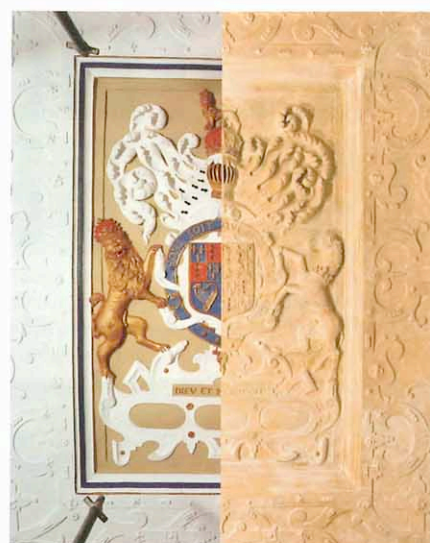
Some means of centring must have been used, as a second layer of pattern, which appears as if formed below the main ribs,

has some very precise circular motifs – too precise to have been formed freehand. It is also likely that the ceiling ribs were created using formwork, as they are quite precise throughout. However, they are not so precise as to suggest the use of running rules, such as those used to form in situ mouldings in a Georgian house. In the Long Gallery, for example, making three or four simple timber octagons would have been an obvious way of making the process quicker and easier. With the octagon formers fixed on a series of chalk lines, the size and position of each octagon could easily be formed using a hand-held mould pushed through the plaster while braced against the outer edge of the timber octagon. The heraldic emblems were hand modelled in situ.

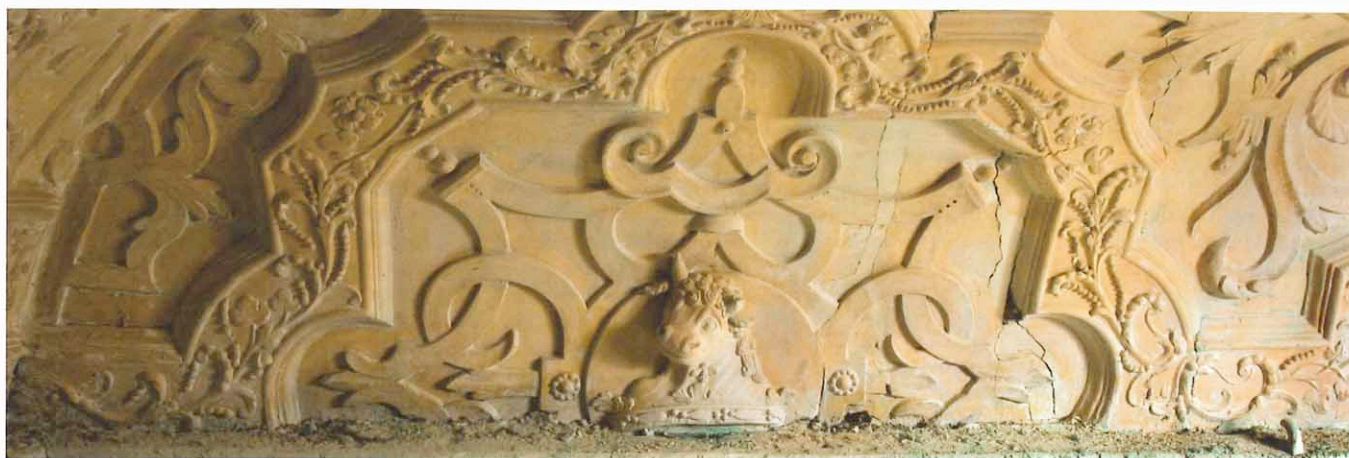
Plasterwork in the Dining Room, the most elaborate of the Jacobean ceilings at Apethorpe

Damage to the cornice in the Dining Room necessitated structural stabilisation and the reinstatement of missing components.

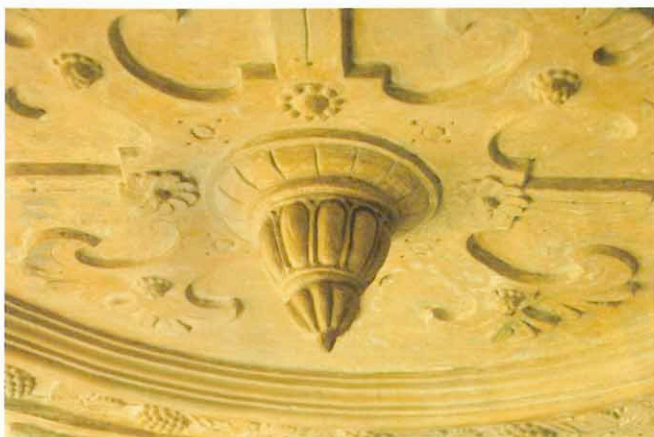
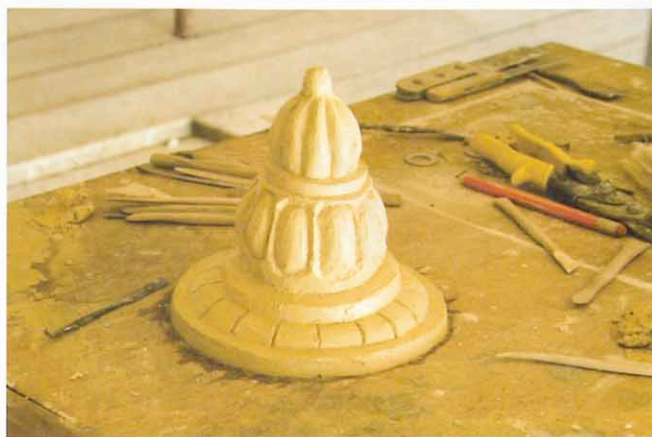
The central pendant was missing here and a new one was made using the repair mortar. It was modelled in a single coat and the basic shape was hand-formed. This was then left for two days to stiffen, at which point the decoration was modelled onto it. The whole process took no more than one hour in actual working time and no cracking occurred in the mortar, which was up to 125mm thick.

The Duke's Room ceiling and (below) the replacement for the missing central pendant
