Apethorpe arising

It is one of the largest single repair and refurbishment projects ever undertaken by English Heritage, calling on the skills of a wide variety of specialists and craftspeople. On page six of this edition of 'Cornerstone' we visit the site now, while here and on the following pages the experts tell of their work – after the momentous compulsory purchase in 2004 the vital second stage to save and prepare this Jacobean gem for an eventual new owner. First, **Mark Balkham, Stephen Oliver and Stafford Holmes** of architects **Rodney Melville & Partners**

Rodney Melville & Partners were appointed Architect for the Phase 1 repair programme in May 2005. Although not necessarily immediately apparent from the exterior, much damage had taken place internally due to leaking roofs and parapet gutters together with blocked sumps and rainwater downpipes. This had resulted in failed ceiling structures, floor structures and damaged plasterwork. To avoid the potential complete collapse of some of the most important decorative plaster ceilings, crash decks had been installed during previous Urgent Works below ceilings in most of the first floor East and South Range principal rooms

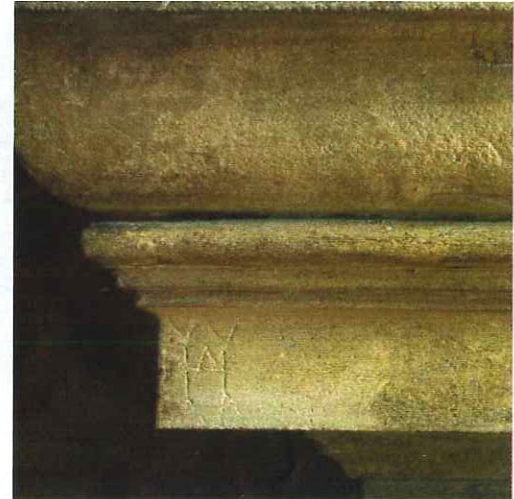
Far left, one of Bowman's stonemasons repoints the East Range gable. Left, one of more than 800 masons' marks found at Apethorpe, this one on a fireplace

Generally, the stonework is in good condition, although extensive areas of pointing had failed at high level, in particular to the chimneys, copings and other weathering details. In addition, some inappropriate cementitious pointing had been carried out to extensive areas of the coursed dressed rubble stonework to the South Range. Large areas of pointing had fractured and had become detached from the stonework. Damage had also occurred through corroded iron fixings to some of the chimneys and gables.

As King's Cliffe stone is no longer quarried, extensive research was carried out to find suitable alternatives. English Heritage was fortunate in having a stock of Weldon stone (also now no longer quarried) at nearby Kirby Hall, some of which has been used for the repairs. Clipsham stone has been used for repairs to weathering details. A range of lime mortars were prepared for matching and selection. Different mortar strengths with varying aggregate sizes have been used to suit joint sizes and exposure. Repairs to damaged stonework have included isolated replacement, piecing-in and mortar repairs depending on the detail, location and severity of the decay. Masonry repairs are carefully being carried out by Bowman's own masons.

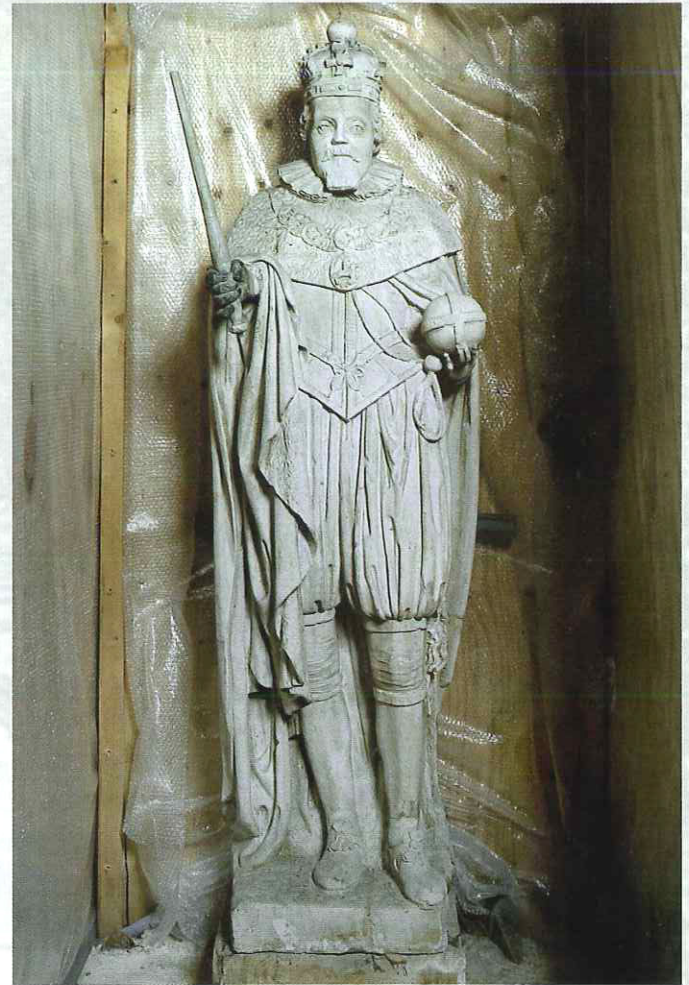
Right, protected during conservation, a 1620s statue of James I. It was originally located over the main doorway into the State Apartment. Below, the very dilapidated arcade in the East Range in 2000
